GEOS 3018

# Stormwater Pollution in the Georges River Catchment

Recommendations to the Sydney CMA

**Semester 2, 2012**

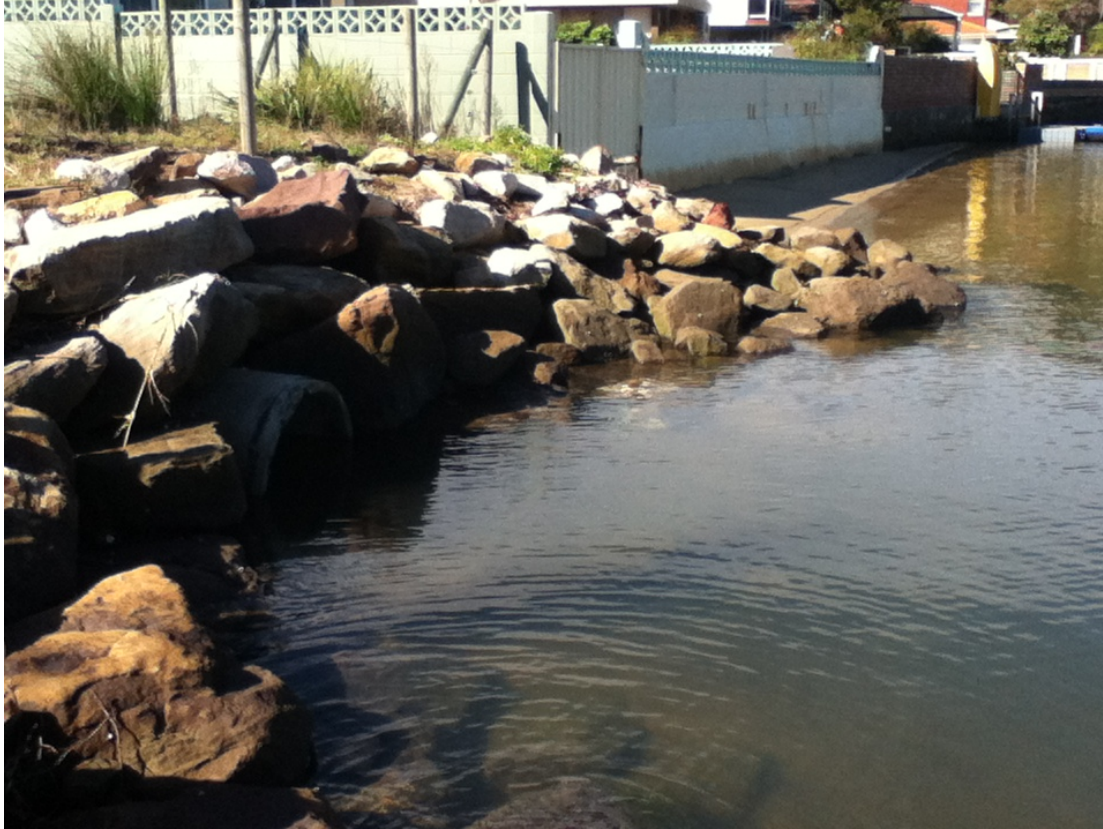
Our first site is a heavily modified system, Kyle Bay. Land surrounding the Kyle Bay site combines commercial, residential and recreational usage. Kyle Bay has 6 small stormwater pipes that flow directly into Kyle Bay (Figure 2.1). There is no observable measure to stop pollution and erosion from the pipes. Erosion from strong flow events is evident along with pollution stemming from unfiltered and untreated stormwater (Figure 2.2). Large pieces of paper and plastic can be seen flowing out of the pipes. This does not allow large treatment to occur. In our opinion this is the worst site, with a heavily modified system not making any attempt to filter the water and not creating an environment for the ecology of the region.

**Figure 2.1: The stormwater release pipes at Kyle Bay**

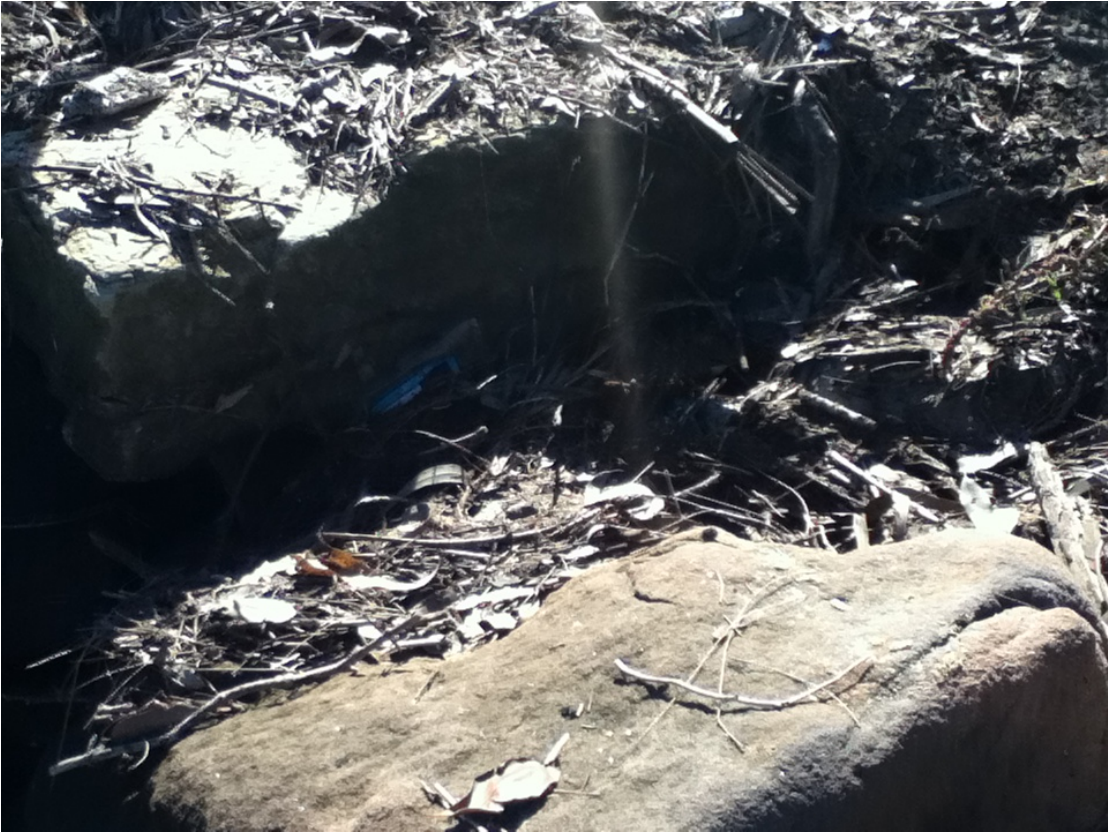
**Figure 2.2: Pollution at Kyle Bay**

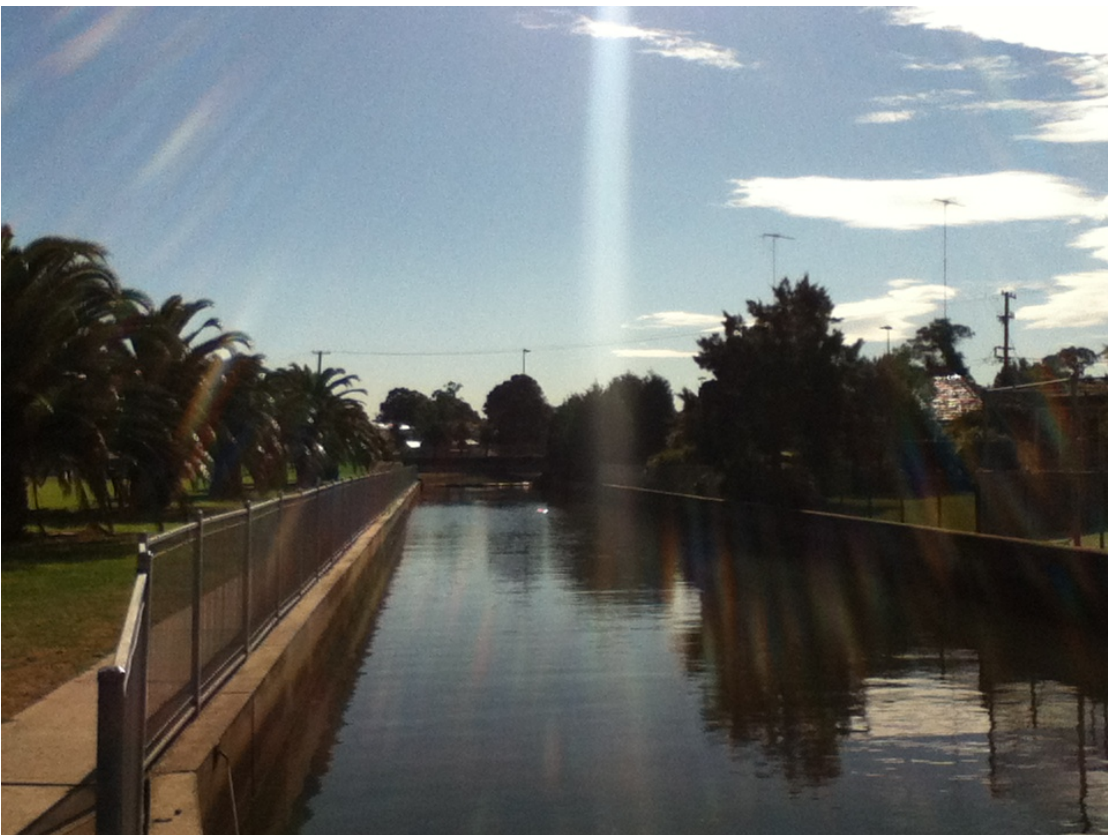
Carss Park is another heavily modified system that flows into The Georges River. It consists of a large open cement canal that is influenced by the tides (Figure 2.3). The only visible attempt to treat the stormwater is a floating net which captures large rubbish, but fails to stop dissolved sediment and pollution; this can be unsightly as is shown (Figure 2.4), with a large sludge collected at the net. The canal often gives off a noxious smell that is at odds for the surrounding expensive real estate. The canal is so heavily modified the biology of the region is almost extinct, only small fish were seen at the mouth of the canal while all plant life has been removed for surrounding land uses. An artificial wetland at the site is hypothetically possible in the park surrounding the canal but is unlikely to occur because of the sporting grounds that would be affected.

**Figure 2.3: The Carss Park Canal**

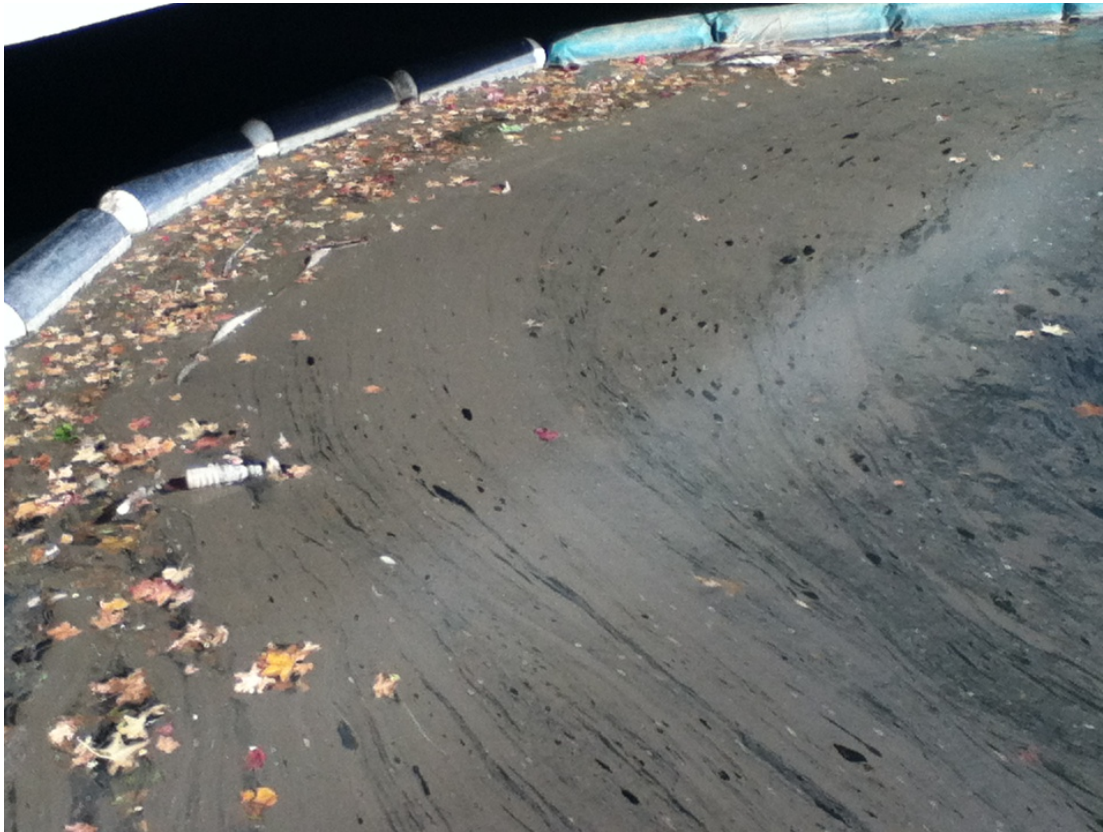
**Figure 2.4: Pollution at the Boom net at Carss Park**

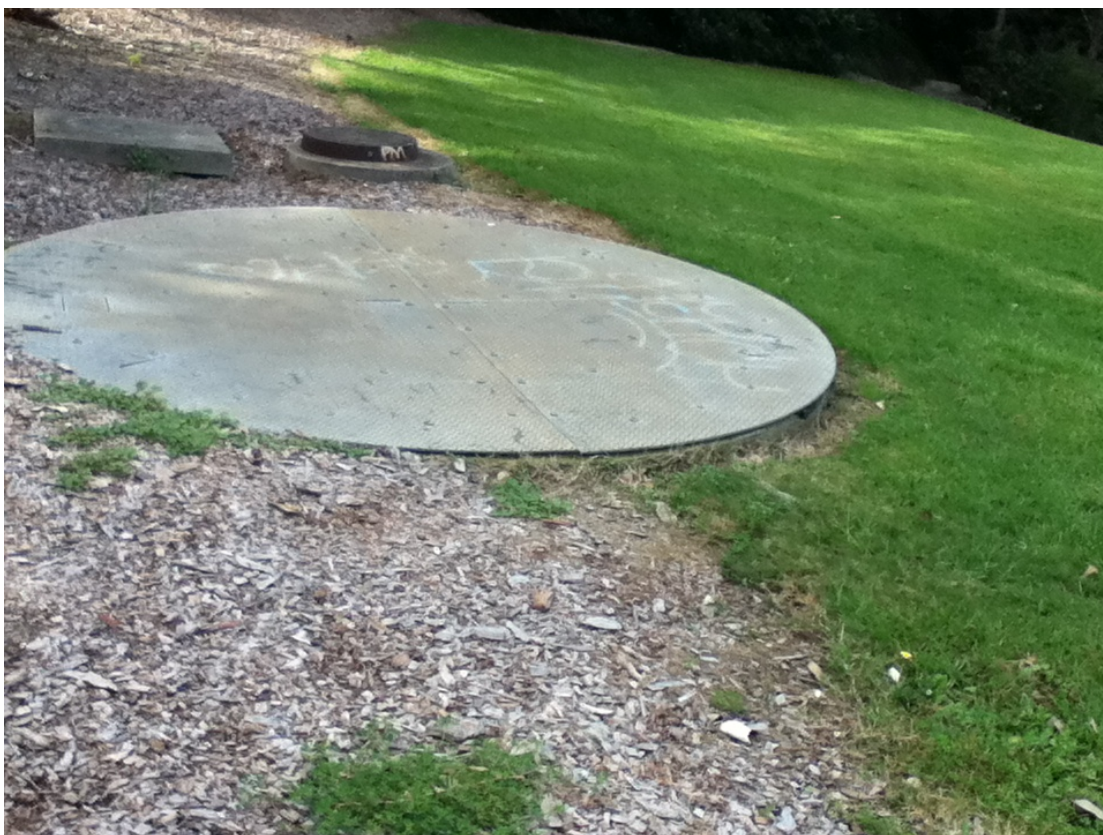
Moore Reserve Wetland is an unnatural engineered system constructed to act as a natural wetland. An in depth look at how this site works is provided in section 4. Water flowing in an underground pipe, which was initially Renown Creek, first goes through a gross pollutant trap (Figure 2.5) to catch large items before reaching the surface and entering a large sediment pool (Figure 2.6). The sediment pool allows the water to stagnate and drop suspended sediment that would otherwise enter the river. The water then travels through reeds (Figure 2.7) to removed dissolved elements in the water before going through another large pollution trap and back into a pipe to enter the river 300m away. It is evident that this system is desirable to the two previous mentioned schemes because the run off is treated before entering the river. The council's objectives of adding to the amenity value of the land as well as helping the biodiversity have been realised with many residents using the wetlands as a recreational walking destination and natural species are flourishing. The main draw back is the cost of the scheme to mimic natural settings, which cannot feasibly be paid to fix every site within a council budget.

**Figure 2.5: The underground gross pollutant trap at Moore Reserve, identical to the Poulton Creek gross pollutant trap.**

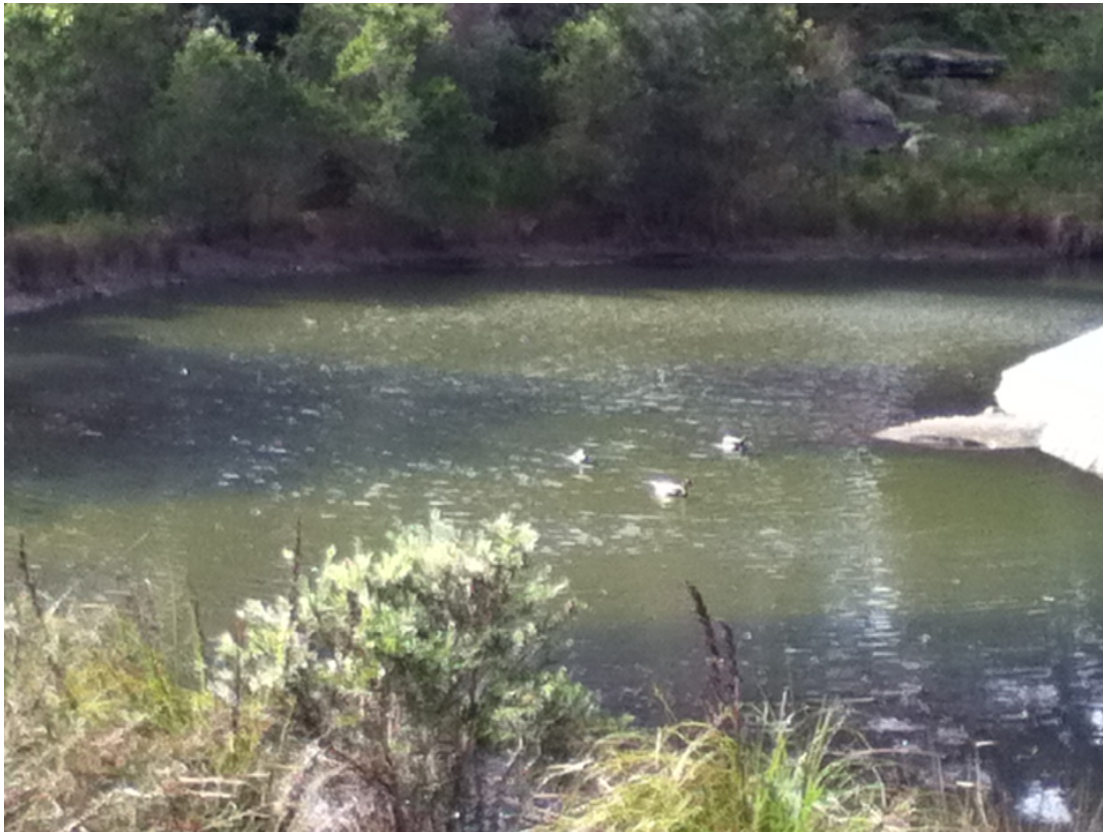
**Figure 2.6: the sediment pond with wildlife (ducks) swimming on the artificial pond.**

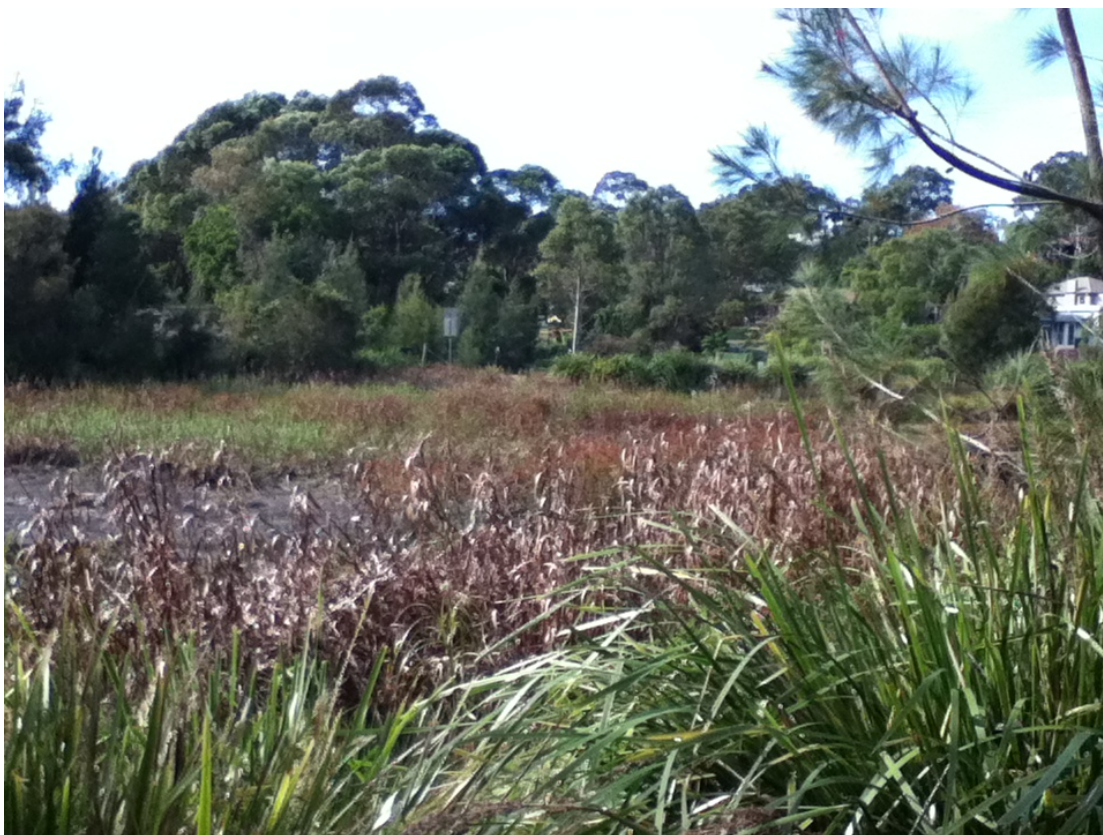
**Figure 2.7: the reeds at Moore Reserve.**

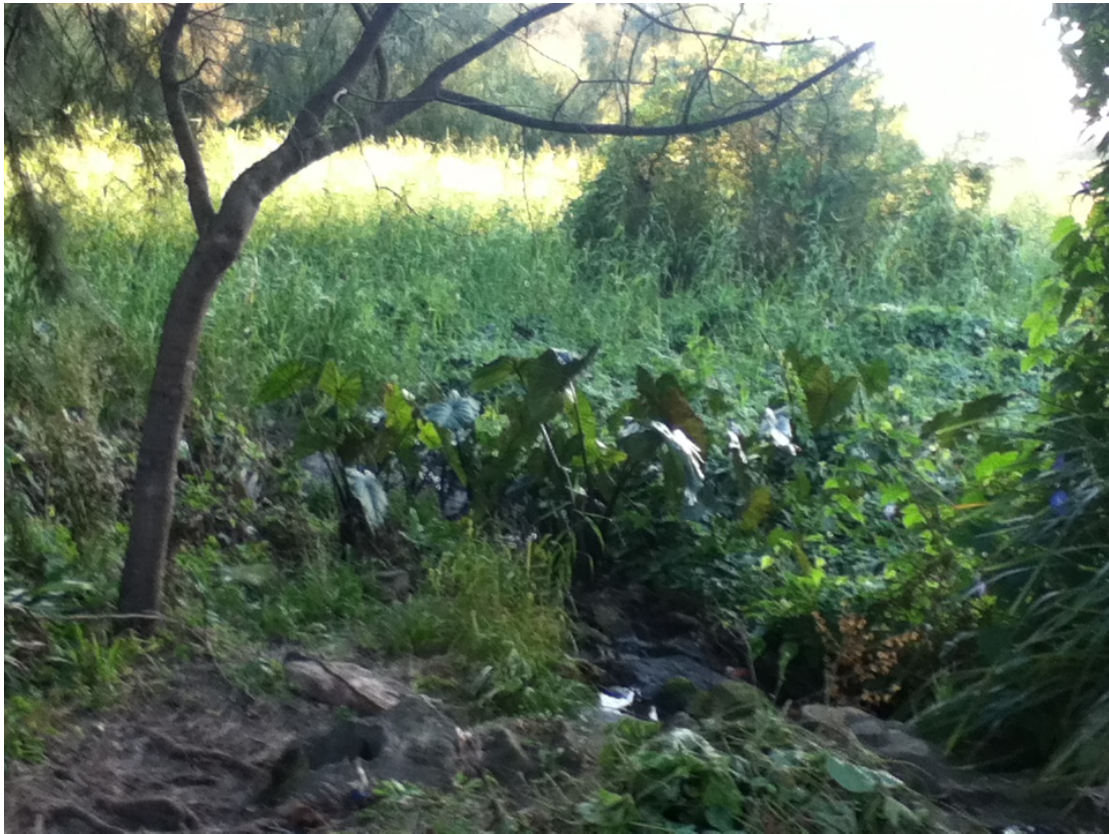
Lime Kiln Bay is similar to Moore Wetland but had a pre-existing Wetland with natural reeds and a large mangrove swamp (Figure 2.8). The City of Hurstville council has constructed 3 large sediment ponds to deal with sediment in the stormwater (Hurstville City Council 2008). Before entering the ponds stormwater travels through surface gross pollutant traps, which is unsightly and has a noxious odour (Figure 2.9). To handle a flood event there is an overflow, which bypasses the sediment ponds but is a strong orange colour (Figure 2.10). The beds of the creeks leading into the system have a strong orange colour (Figure 2.11), which may be clay or harmful metals which give them the appearance of contamination. This is an issue for water entering the system upstream but the wetlands mean this pollution does not enter the Georges River; This is covered in section 1. Due to the location of being next to the large nature reserve of Oatley Park there is strong biodiversity but vandalism of educational material was observed.

**Figure 2.8: The Natural wetlands at Lime Kiln Bay, looking towards the mangrove swamp.**

A large, natural/constructed and managed system (see section 2 and figure 2.8). The wetlands exhibit success in treating the polluted storm water before it reaches the river. Exhibited in the lack of litter and reduction in colour and smell of the water

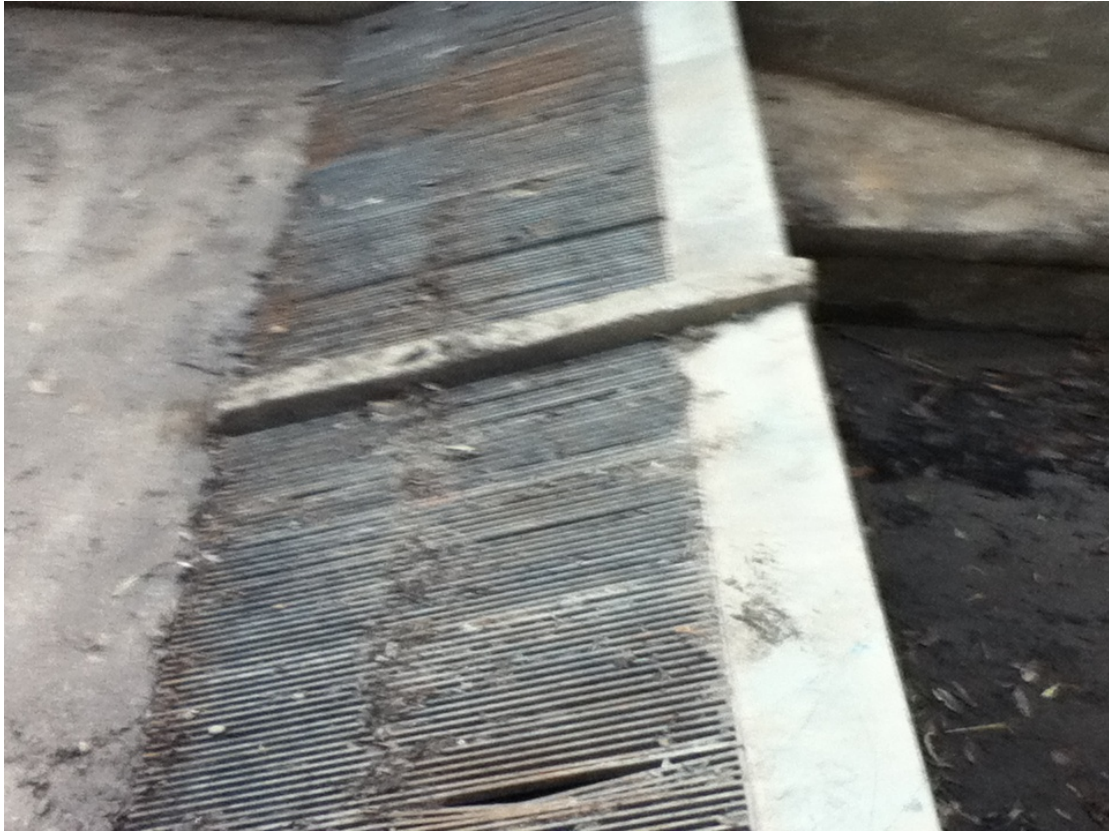
**Figure 2.9: the surface gross pollutant trap at Lime Kiln Bay.**

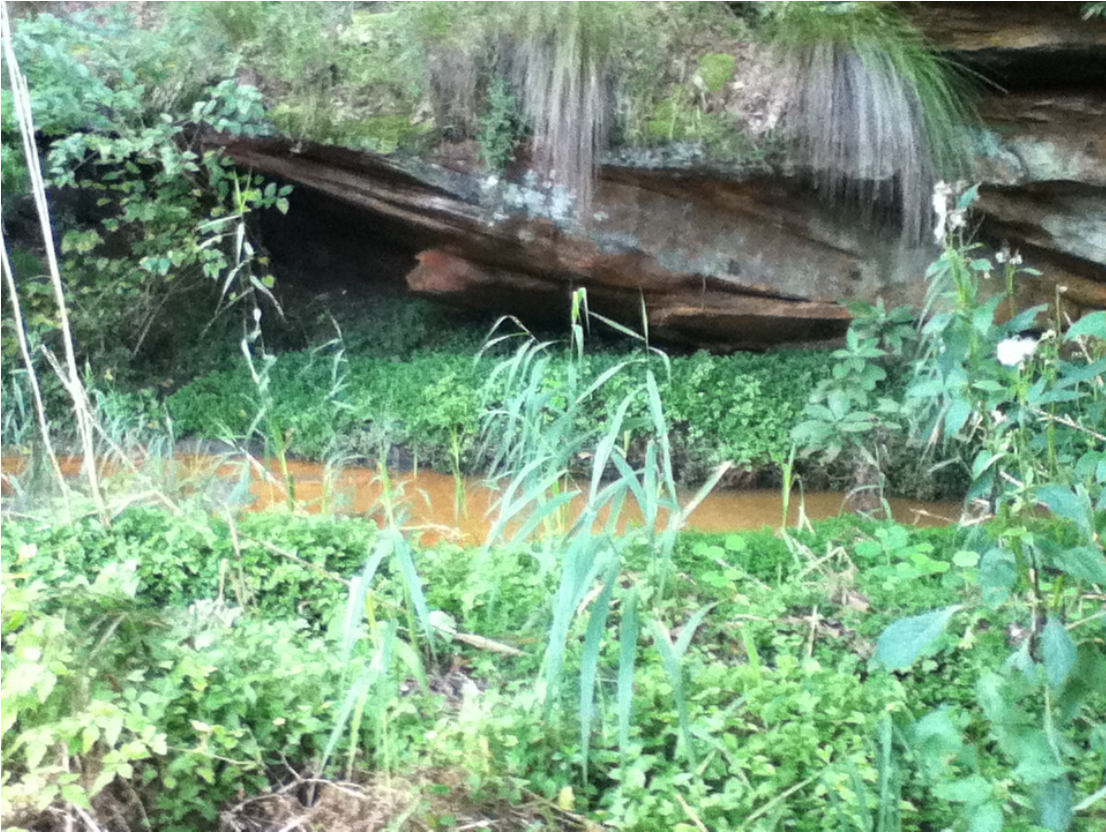
**Figure 2.10: The orange coloured by-pass at Lime Kiln Bay.**

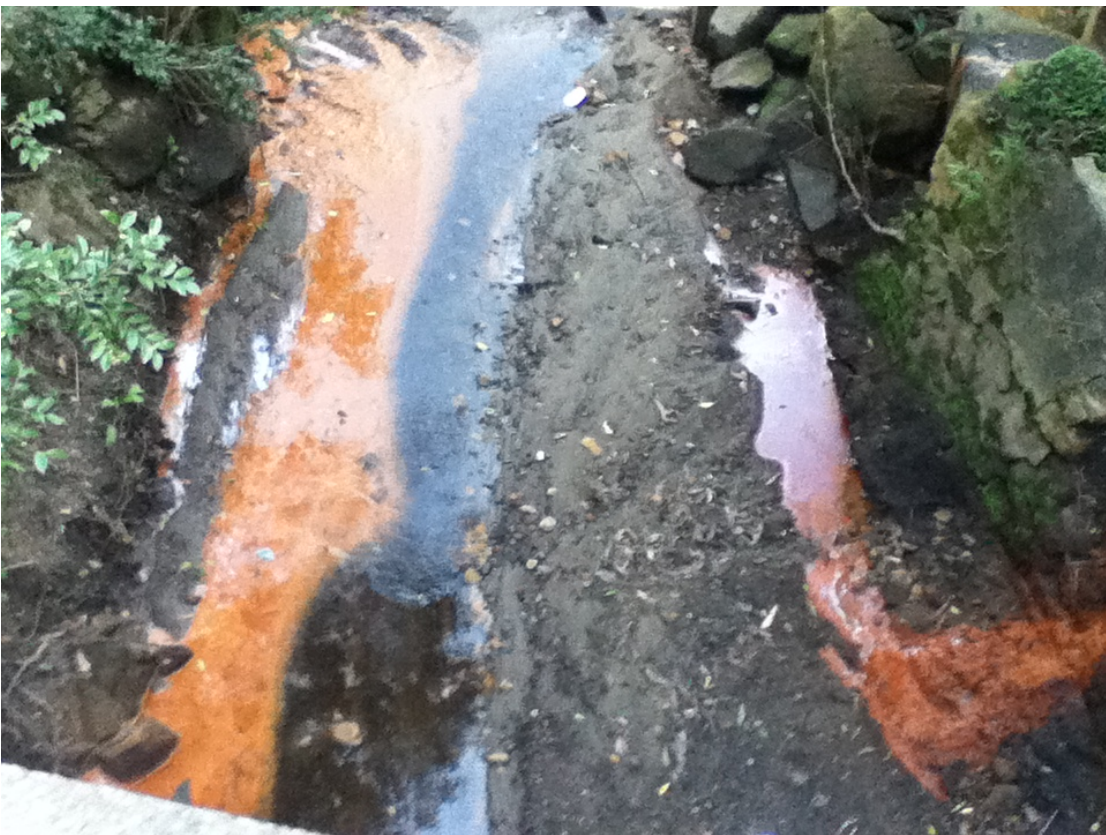
**Figure 2.11: Visible pollution at Lime Kiln Bay, identical to Poulton Creek and Myles Dunphy Reserse.**

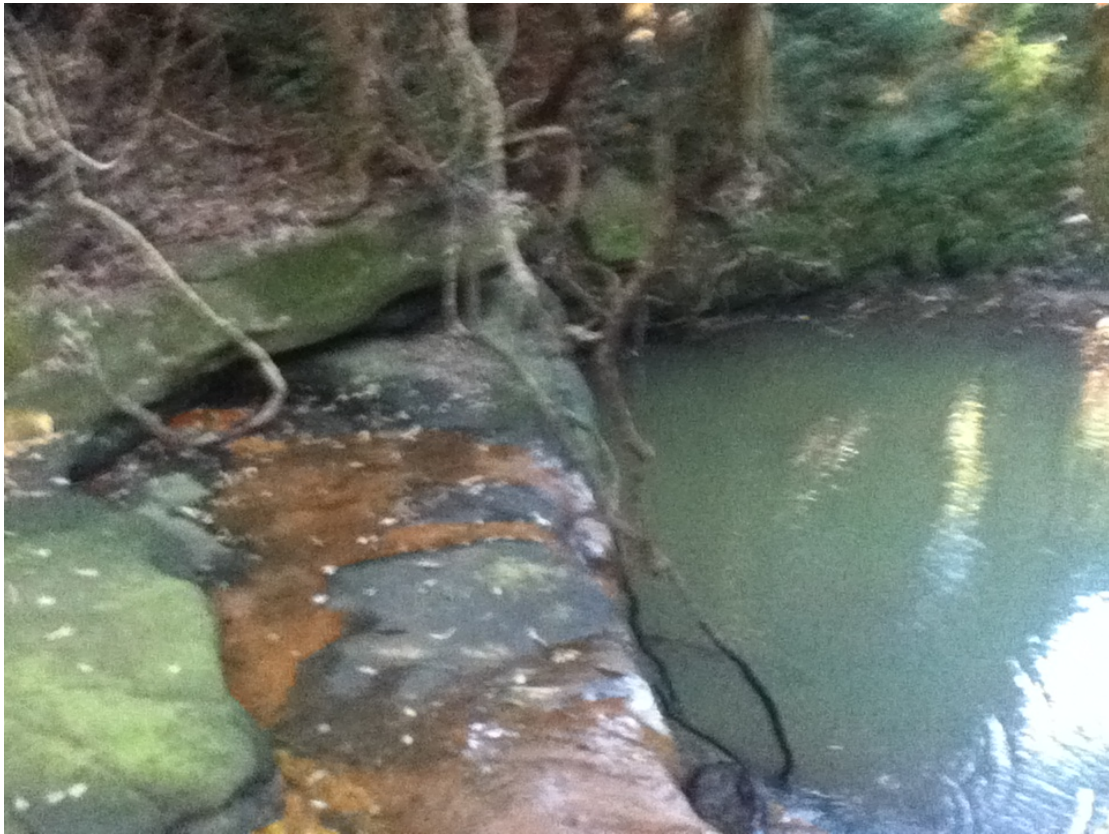
Poulton Creek catchment includes a heavily polluted creek, which flows into a mangrove swamp and an estuary before entering the river. Section 3 covers the workings of natural wetlands in depth. An underground gross pollutant trap has been installed before the creek surfaces from pipes. The creek is visibly heavily polluted with an orange sludge evident along with oil-based pollution sitting on the water (Figure 2.12), which is murky and has a pungent smell. The water quality is not treated until it reaches the rehabilitated mangrove swamp, which is 1 kilometre downstream. The creek flows through bushland that is overrun with introduced Flora and Fauna. The mangrove swamp has been rehabilitated from a state of being heavily polluted, which initially resembled a tip, to a thriving forest (Figure 2.13), which is used as an example of environmental management and education for schools. The estuary acts as a natural sediment pond (Figure 2.14), naturally achieving what costs millions of dollars at Moore Wetland and Lime Kiln Bay.

**Figure 2.12: Pollution at Poulton Creek**

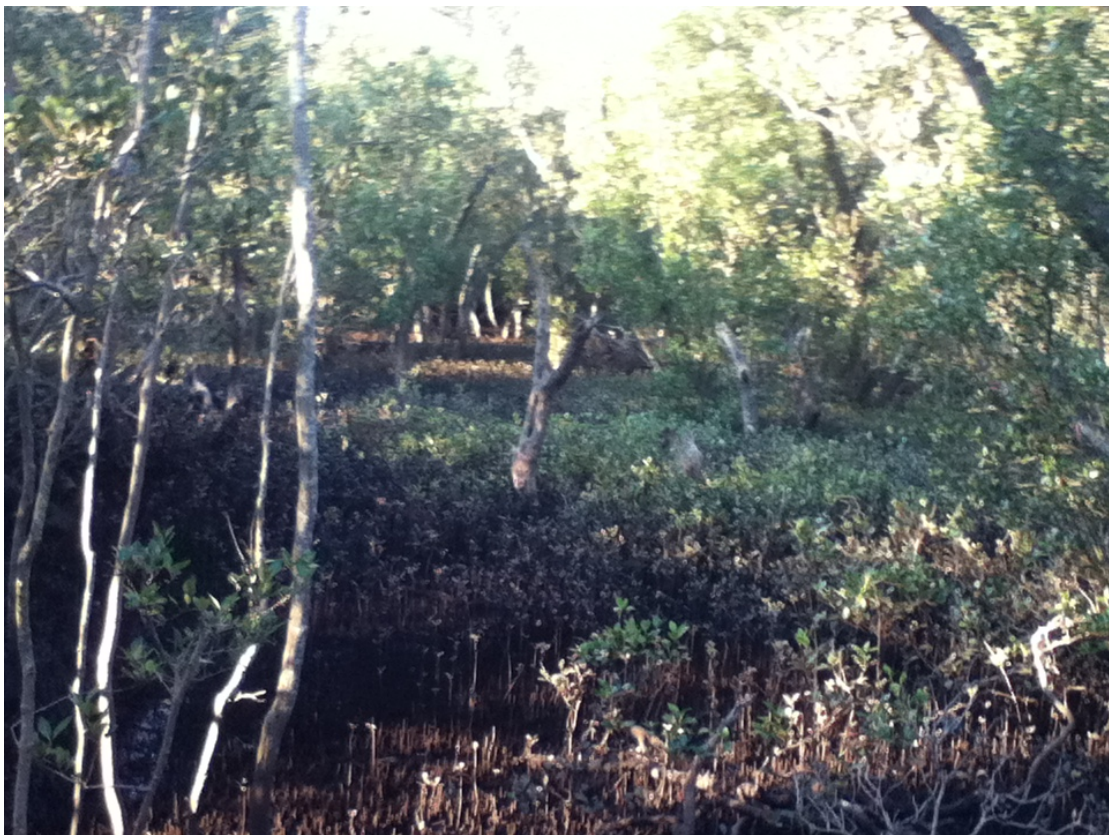
**Figure .13: The Rehabilitated mangrove forest**

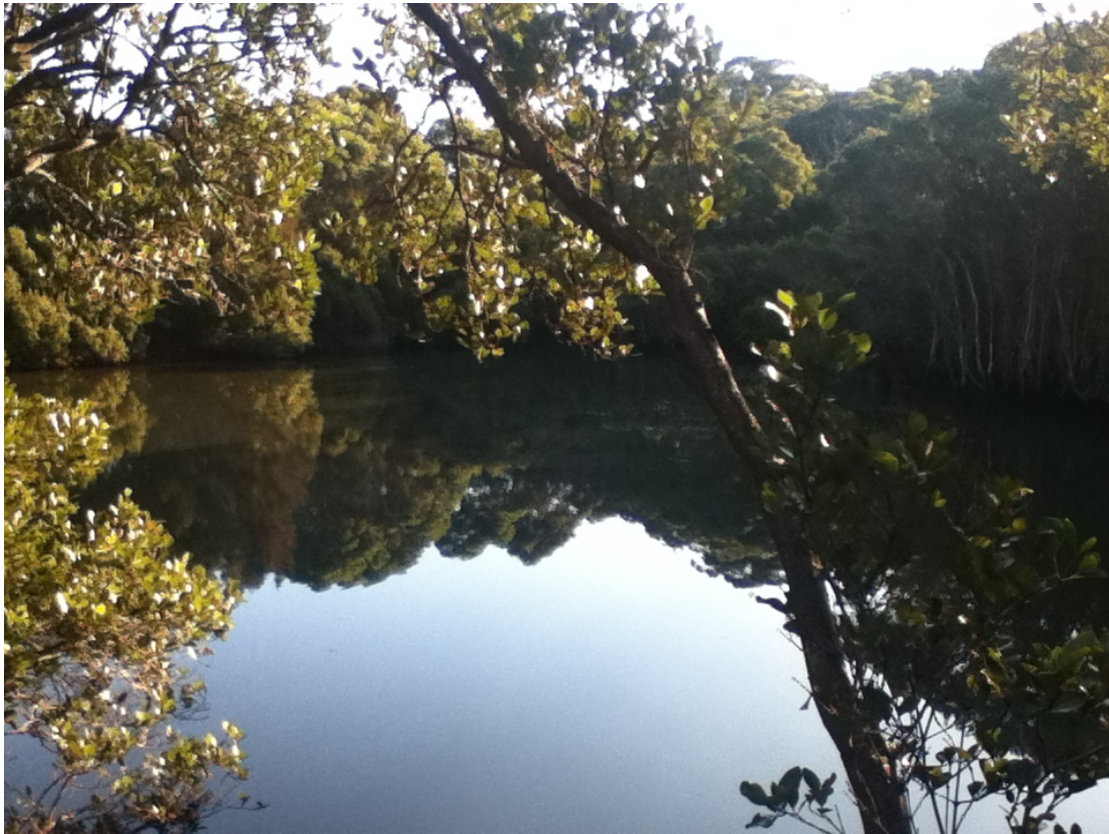
**Figure 2.14: The Estuary**

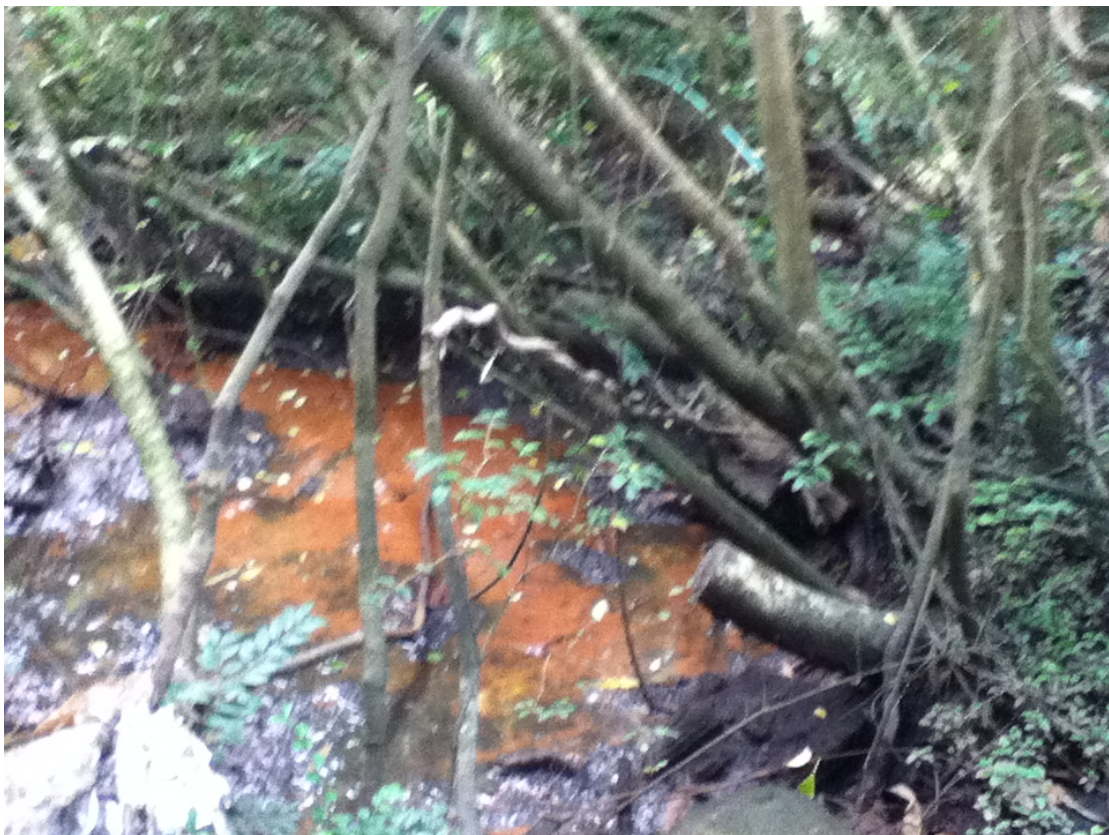
The Last site is almost untouched in terms storm water treatment. Myles Dunphy Reserve is heavily infested with invasive weed species while the wetlands, which flow through, give of a noxious odour. The orange sludge is observed as well as large amounts of the oily pollution

on the surface of the stagnant water (Figure 2.16). A Mangrove forest provides the only water treatment but is a fraction of the size of Poulton Creek or Lime Kiln Bay. Illegal dumping is another major issue which affects the uncontrolled system.

**Figure 2.15: Stagnant and polluted water surrounded by weeds at Myles Dunphy Reserve.**

A small, natural, unmanaged system. The wetlands show a failure in treating the polluted storm water before it reaches the river (see section 2 and figure 2.15). This is exhibited through the consistent smell throughout the river.

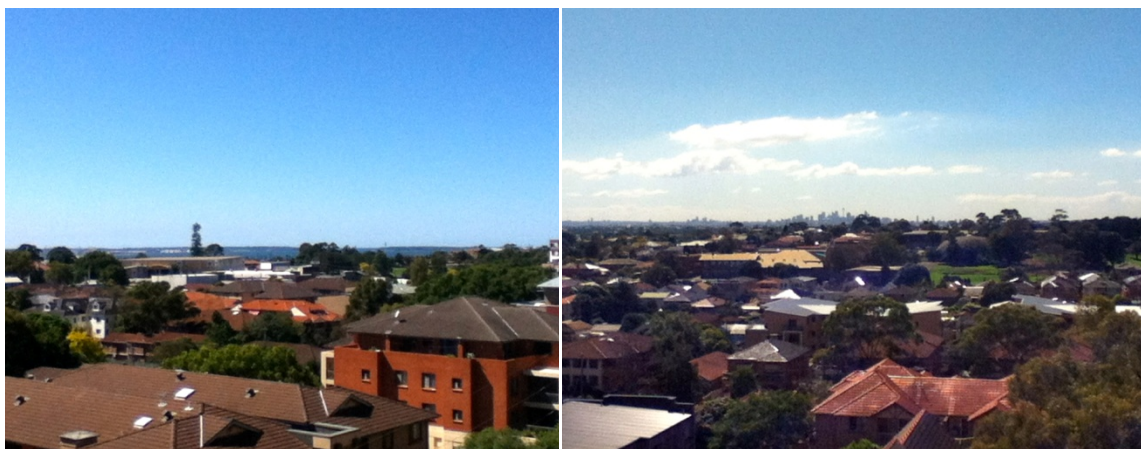
**Figures 3.1.1 (left) and 3.1.2 (right): Examples of urbanisation in Georges River catchment (Source: Kyrie Tsang)**

Based on field observations and the photographic evidence collected, it was clear that the majority of land-use surrounding the Georges River catchment was urbanised (see Figures 3.1.1, 3.1.2 and 3.1.3). In order to help manage stormwater the general public need an awareness of the issues of stormwater borne pollution; where it originates, how it is transported into the Georges River, the contaminants that are transported by it, and how these affect the Georges River and its biodiversity. If communities are made aware of all these factors they can make more informed and responsible decisions about the use and disposal of potential stormwater contaminants in urban environments.

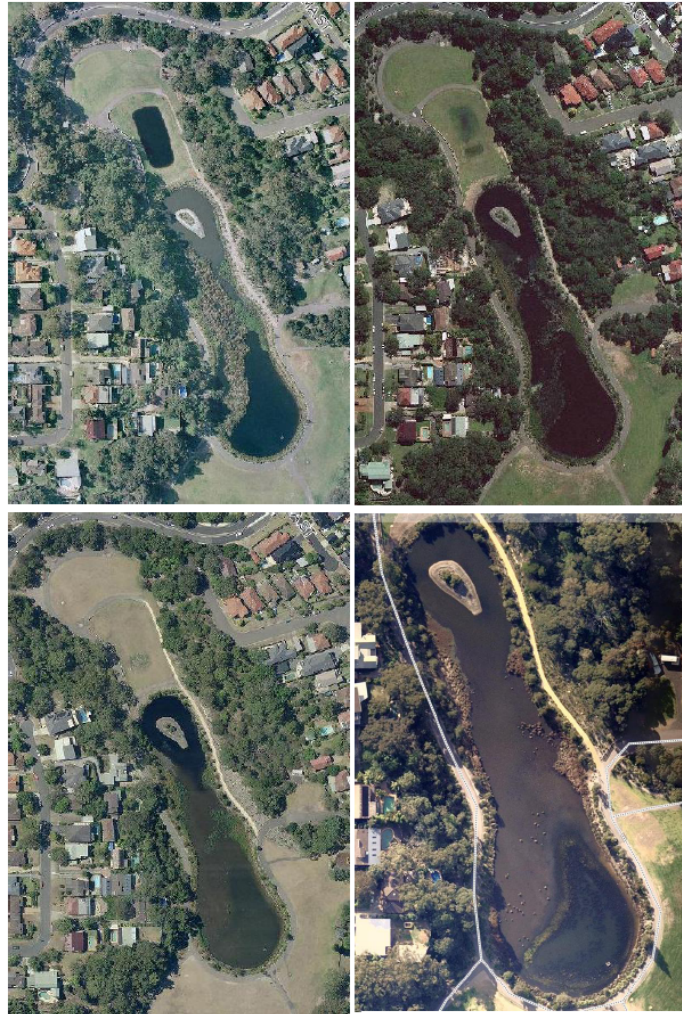
A major assessment of the wetlands was conducted in 2011 (Dalby-Ball and Olson 2011) by Dragonfly Environmental at the request of Kogarah Council. This assessment showed that vegetation cover has decreased substantially since 2004 from 70% to as little as 5%. This is evident from a comparison of aerial photographs (see Figure 5.3.1). Vegetation reduction represents a significant loss in productivity of the system. In response, the assessment recommended revegetation to restore macrophyte cover to at least 30% and the creation of more shallow marsh areas (< 30cm) to encourage vegetation growth. Kogarah Council undertook revegetation of the Reserve in 2011 involving 400 large (8-inch) aquatic plants and 9600 seedlings. 30% of wetland area was revegetated according to Tom Heath, Catchment Management Officer at Kogarah Council (in an e-mail correspondence during May 2012). This is supported by first-hand observations made in April, 2012 (see Figure 5.3.2 and 5.3.3).

**Figure 5.3.1: Aerial photographs showing vegetation cover in 2004 (top-left), 2007 (top-right), 2009 (bottom-left) and 2011 (bottom-right). A progressive loss of vegetation can be seen (Dalby-Ball and Olson 2011)**

Dissolved oxygen was below recommended levels at all tested sites. Low dissolved oxygen is unfavourable for aquatic fauna and may lead to excessive anaerobic decomposition and consequent release of foul-smelling hydrogen sulphide gas. Furthermore, total nitrogen and phosphorous in the water (pollutants that can cause algal blooms) increased upon water entered the wetlands. Turbidity was within recommended levels at inlet and outlet sites, indicating effective sedimentation of particulates in the system. Sustained removal of pollutants is best achieved through regular revegetation and maintenance of existing vegetation.

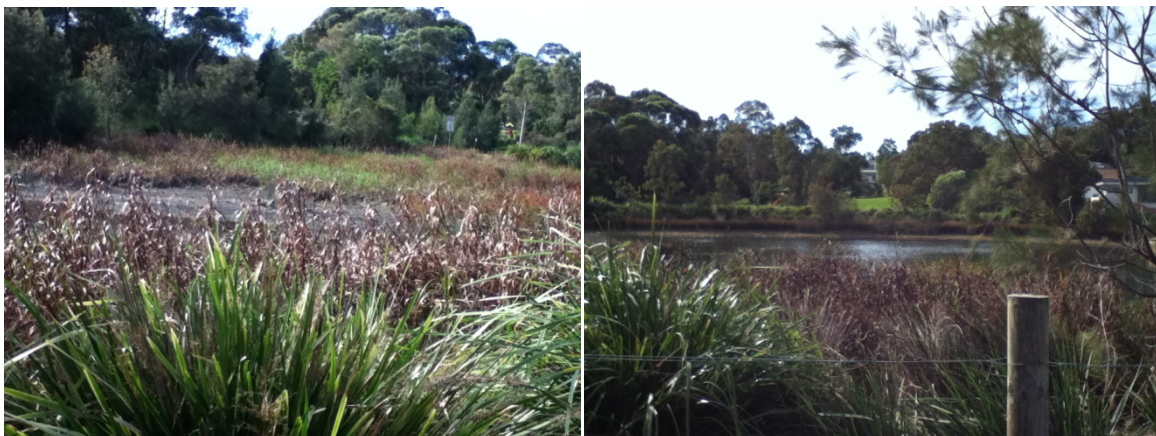
**Figures 5.3.2 (left) and 5.3.3 (right): Examples of first-hand observations made in April 2012 showing evidence of revegetation (Source: Andrew Edenborough)**
